REPORT DOCUMENTATION PAGE		READ INSTRUCTIONS BEFORE COMPLETING FORM
1. REPORT NUMBER VA 16303	2. GOVT ACCESSION NO.	3. RECIPIENT'S CATALOG NUMBER
4. TITLE (and Subtitle) Phase I Inspection Report National Dam Safety Program ROBERTSON DAM ROCKBRIDGE COUNTY, STATE OF VIRGINIA		5. TYPE OF REPORT & PERIOD COVERED 9 Final rept

NAME OF DAM: ROBERTSON DAM

PHASE I INSPECTION REPORT
NATIONAL DAM SAFETY PROGRAM
NAME OF DAM: ROBERTSON DAM ID# VA 16303

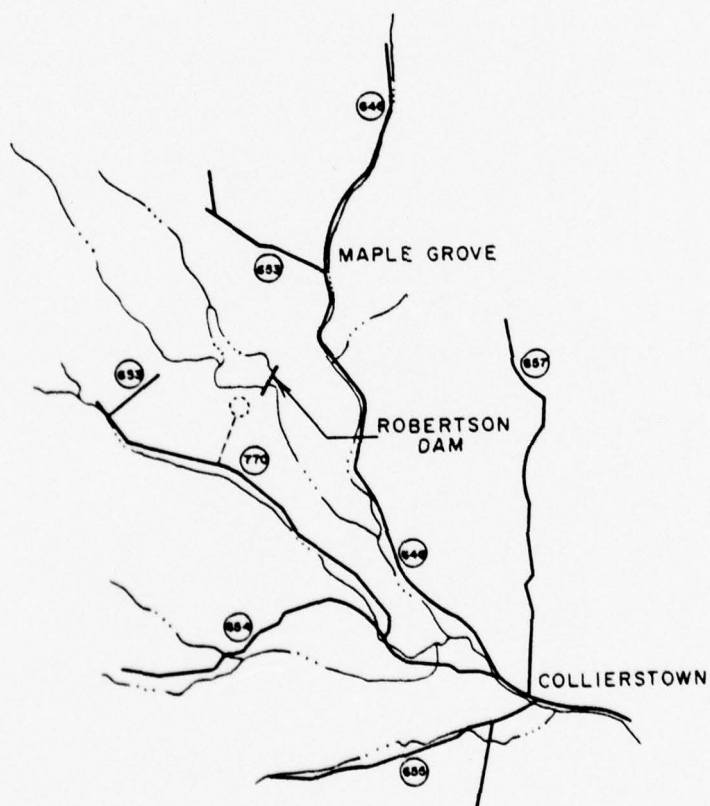
FIELD SKETCH
ROBERTSON DAM, VIRGINIA
PLATE 1
Michael Baker, Jr., Inc.
5 June 1979

3.1.2 Dam: A zone of sloughing approximately 20 feet wide extends from the crest of the dam to the toe of the downstream slope (sloped at 2.5:1) near its junction with the right abutment (see Plate 1 and Photo 7).

discharge channel, minor slumping has occurred (see Plate 1). Clear seeps (too small to measure) are occurring in this area which are probably related to bedrock springs. This assumption is supported by the presence of a spring which was noted during the planning stage. The spring is at approximately the same elevation as the bedrock outcrop on the left abutment and just upstream of the dam centerline (see bedrock and spring indicated in the left abutment area on Plate 2). Surface runoff and a few animal burrows are aggravating this condition.

Appurtenant Structures: Minor erosion and a few unvegetated areas were observed in the discharge channel of the emergency spillway. The left downstream corner of the concrete apron, onto which the dam outlet pipe discharges, has begun to deteriorate. Insufficient riprap surrounds the upstream sides of the stilling basin and the outlet structure to provide protection for the toe of the dam (see Photo 3 and Plate 1).
